Composite Flooring System Keeps Plant Clean

Challenge: Protection of concrete processing floors from corrosive organic acids

Solution: Installation of acid-resistant brick pavers with FURALAC Green Panel Mortar as a bedding adhesive atop PENNCOAT 101 Membrane asphalt and FLEXJOINT Joint Sealant used in between brick side joints

PROJECT PROFILE

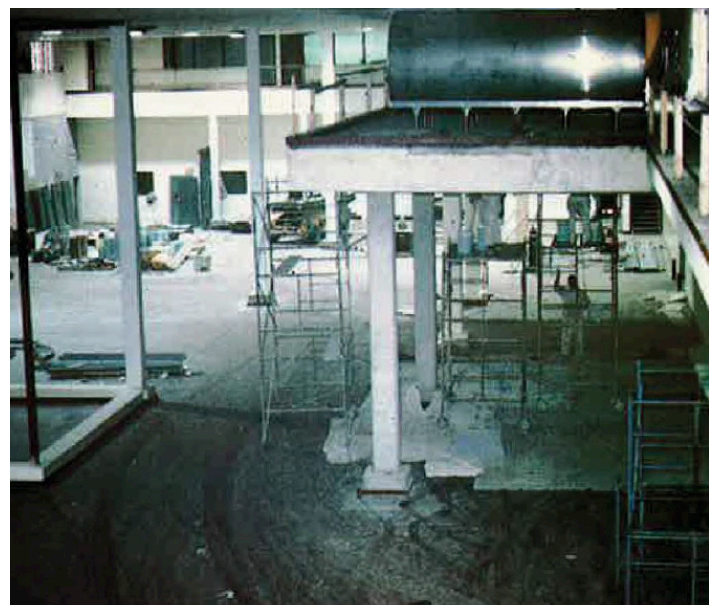
The flooring in these sections consists of 1-3/8 inch thick smooth-faced acid-proof brick pavers bedded in furan resin cement (FURALAC Green Panel Mortar) laid atop a reinforced hot melt asphalt membrane (PENNCOAT 101 Membrane).

The three-component membrane system started by priming the concrete with an asphalt that is compatible with the succeeding layers. Hot-melt, unfilled oxidized asphalt was then applied in several thin layers to a thickness of 1/4-inch and reinforced with a single ply of asphalt-impregnated glass.
