Sweet Flavors that Sour Conventional Floors Call for a Three-Component Membrane System

Congers,
New York

Ice cream ingredient production

Solution: Acid-resistant brick pavers with PENNCOAT 101 Membrane underneath FURALAC Red Panel Mortar bedding adhesive and FLEXJOINT Joint Filler for brick side joints

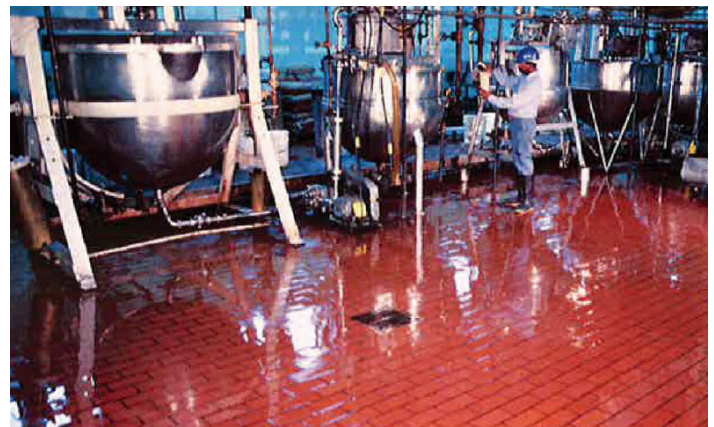
There are three critical areas in Star Kay White's new 30,000 square foot plant that require flooring that is impervious to chemical action, and to thermal and physical shock: a 200 square foot storage and mixing room, a 1,400 square foot candy manufacturing room, and a 2,700 square foot processing area. It was agreed that 1 – 3/8 inch abrasive surface red shale pavers would provide the necessary strength for floor loads. Perimeter

areas would be finished with 5 inches smooth, round-top coving. To meet the demands of chemical resistance and thermal shock, the installation utilized a three-component asphaltic membrane system (PENNCOAT 101 System) over concrete substrate. A polyfurfuryl alcohol-based mortar (ErgonArmor's FURALAC Red Panel Mortar) was selected for the tile bedding and grouting because of its high resistance to strong acids and alkalis.

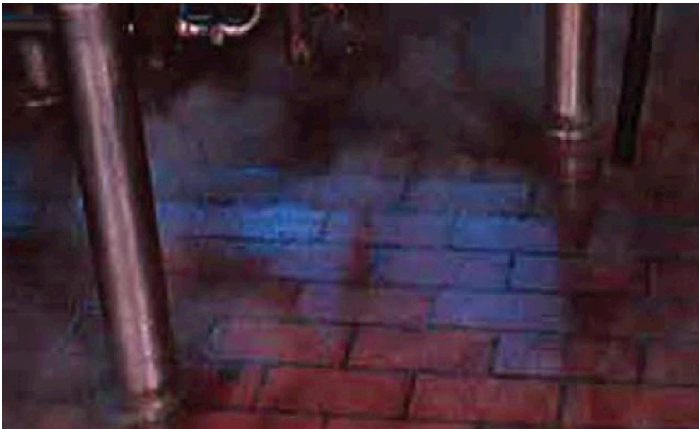
Concrete areas were first given a liberal coat of primer (PENNPRIME 101) which serves as the bonding agent for the glass-reinforced, 1/4 inch asphalt membrane. Then the membrane itself—a hot-melt, unfilled oxidized asphalt—was applied in several thin layers to a thickness of 1/4 inch and reinforced with a single-ply of open mesh woven glass cloth saturated with the same asphaltic compound.

The furan mortar was applied over the membrane at a nominal 1/8 inch thickness. The tile setter's method was then used to lay the pavers.
